DEPARTMENT OF TRANSPORTATION**DIVISION OF ENGINEERING SERVICES**

Contract #: 04-0120F4Cty: SF/ALA Rte: 80 PM: 13.2/13.9File #: 69.28**WELDING INSPECTION REPORT****Resident Engineer:** Pursell, Gary**Address:** 333 Burma Road**City:** Oakland, CA 94607**Report No:** WIR-002828**Date Inspected:** 07-Jun-2008**Project Name:** SAS Superstructure**OSM Arrival Time:** 630**Prime Contractor:** American Bridge/Fluor Enterprises, a JV**OSM Departure Time:** 1530**Contractor:** Zhenhua Port Machinery Company, Ltd (ZPMC), Changxing Island **Location:** Shanghai, China**CWI Name:** Chen Xi**CWI Present:** Yes No**Inspected CWI report:** Yes No N/A**Rod Oven in Use:** Yes No N/A**Electrode to specification:** Yes No N/A**Weld Procedures Followed:** Yes No N/A**Qualified Welders:** Yes No N/A**Verified Joint Fit-up:** Yes No N/A**Approved Drawings:** Yes No N/A**Approved WPS:** Yes No N/A**Delayed / Cancelled:** Yes No N/A**Bridge No:** 34-0006**Component:** OBG**Summary of Items Observed:**

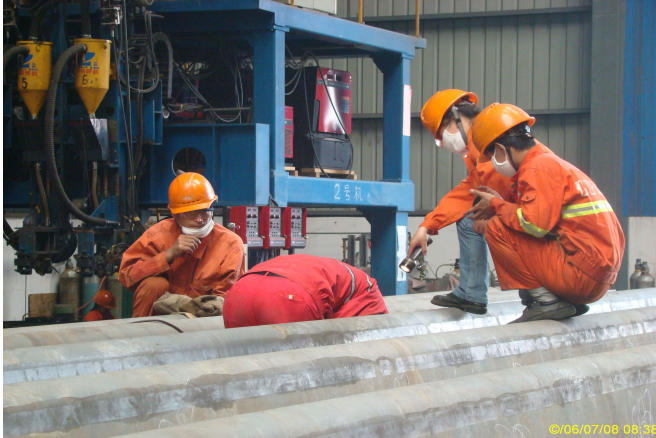
This QAI observed the GMAW root welding of Deck Panel DP556-001 on gantry 1. Welders and essential welding variables are shown below. There were two areas on the root welds which will require weld repair prior

to welding the SAW cover passes.

On Deck Panel DP591-001 ZPMC QC performed magnetic particle testing 100% of the tack welds and found a number of tack welds which did not appear satisfactory. Repairs are going to be carried out and welding of the roots and covers should take place late in the afternoon.
